REHABILITATION OF A FRANCIS TURBINE OF POWERPLANT SCHWARZACH, AUSTRIA

M. Mione, G. Mazza, Fravit, Italy
G. Aigner, P. Hassler, Austrian Hydro Power AG, Austria
H. Wohlfarth, FV-Stell Engineering, Switzerland

The rehabilitation of the Francis turbine group 1 of Power Plant Schwarzach (Austria) is presented, taking into account the background problems linked to the liberalization of the european energy markt. The technical challenge has the goal to reduce the re-assembling time on site and increase the turbine life time.

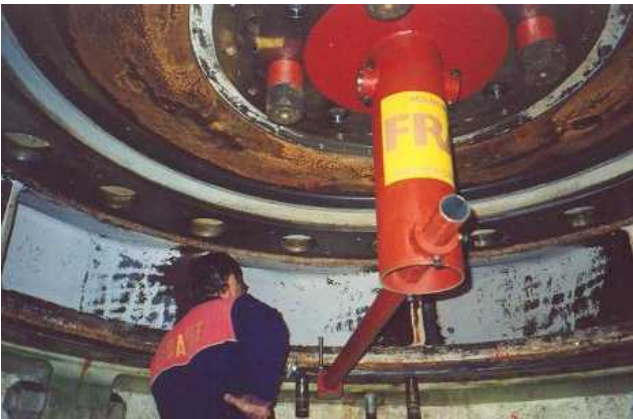
Geometrical inspection of the whole position of the shaft and of the perpendicularity of the flanges of the spiral case to it. This operation is performed in the power plant with a special equipment designed by FRAVIT after dismantling of runner, blades and at least one cover. These measurements enable the definition of the exact relative geometry of the wear rings and the guide vane blades (s. Fig. 1).

Fig. 1 – on site measurements of the turbine geometry

The correction of the spiral casing by means of a portable milling machine (performed by FRAVIT several times in Italian plants) was in this case not necessary, as the deviations were very small.

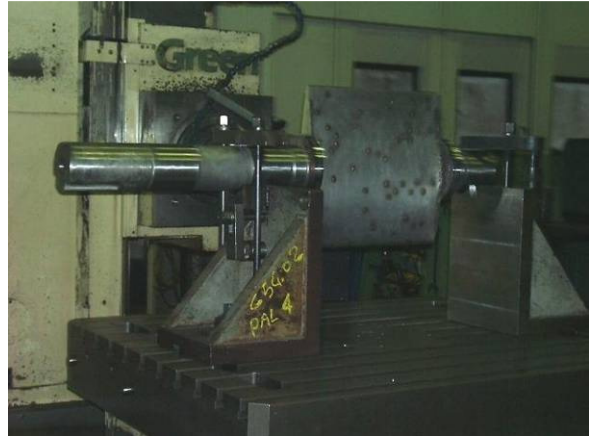
Welding, turning, CNC-machining of bores and blades, grinding and coating have been performed according to procedures that have been followed respecting the ISO 9000 certification of the FRAVIT company with full documentation of each step of the working process (s. Fig. 2 and 3).

Fig. 3 – repairing of guide blades

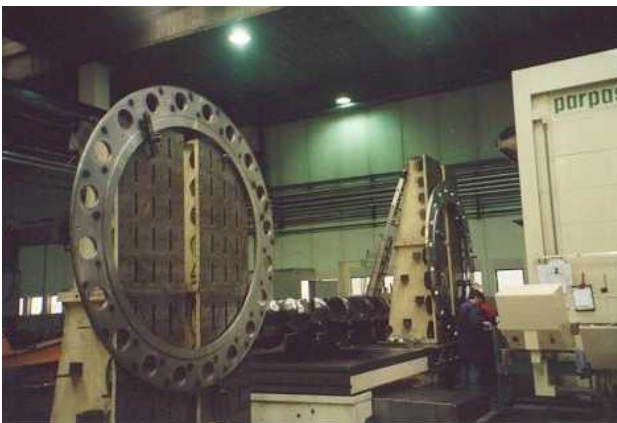
Fig. 2 – CNC-machining of rings

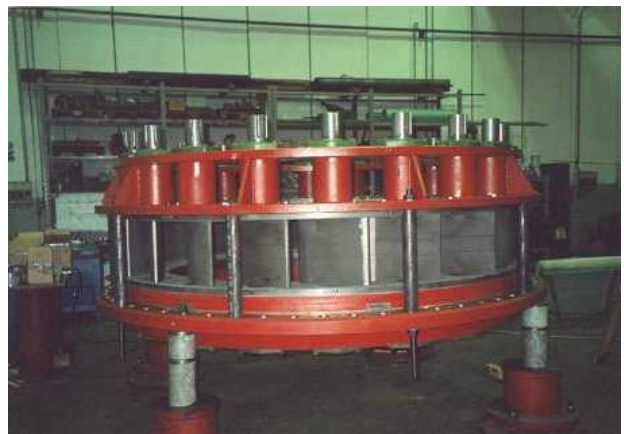
Preassembly of the guide vane group with turbine head cover and guide vane rings, including the new wear rings, has been made in order to check the very small gaps of the guide vane blades to its wear rings and to prevent any delay during the re-mounting on site (s. Fig. 4). In this way the targets of eliminating on site adjustments on the parts and at a time of reducing the assembly time have been achieved.

Fig. 4 – pre-assembly in FRAVIT workshop (simulation of the actual conditions on site).

The pre-assembly has to take into account that, in old turbines, mainly because of concrete settlement of the spiral casing, there is no certainty that the shaft and the spiral casing are perfectly perpendicular. If this is not the case, the pre-assembly in the workshop does not give any reliable picture of the assembly on site.
