REPAIRING CAST PELTON RUNNERS: PROBLEMS AND MODERN SOLUTIONS

M. Mione and **G. Mazza**, Fravit s.r.l.

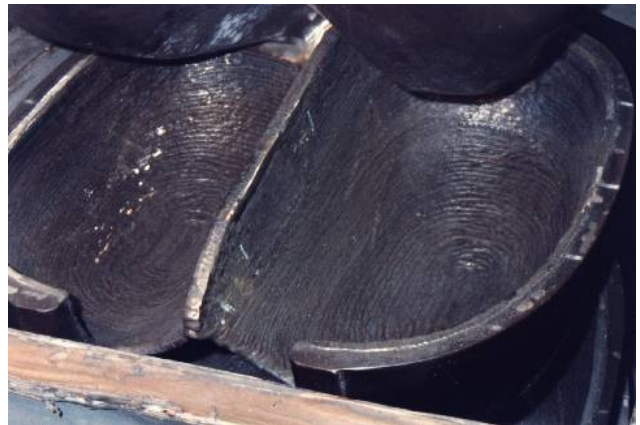
Fig. 1 – TIG welding of the buckets

- Pulsed-TIG welding: by TIG-welding (s. Fig. 1) the lowest heat rate and the best control of the weld quality can be achieved. The mechanical properties are also better than those achieved by other methods (s. Diagr. 1).

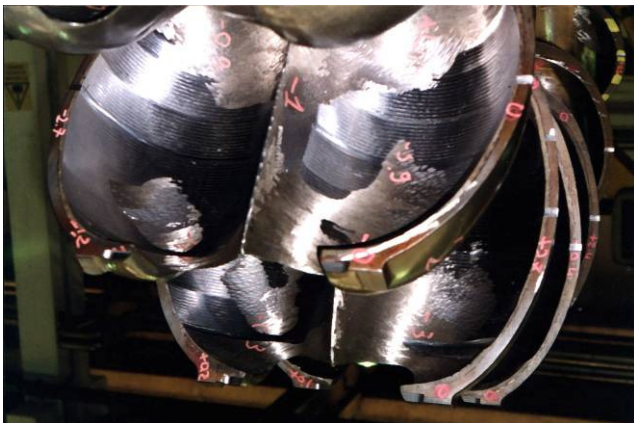
Fig. 3 – Preliminary CNC machining – also shown are the “spots” in the milled surface

- Initial measurements: verification of bucket's angular position with CNC machining, using the internal bottom of the buckets as reference point, given that the planes are not reliable.
- Pre-machining with a CNC machine of the bucket's profiles and planes (s. Fig. 3), on the basis of the theoretical CAD/CAM surface, to make the bucket's division as uniform as possible and the surfaces as regular as possible, to make the subsequent welding easier.
- Pre-welding: the initial measurements are used to decide whether to fill some zones by welding, so as to make the surface more uniform.

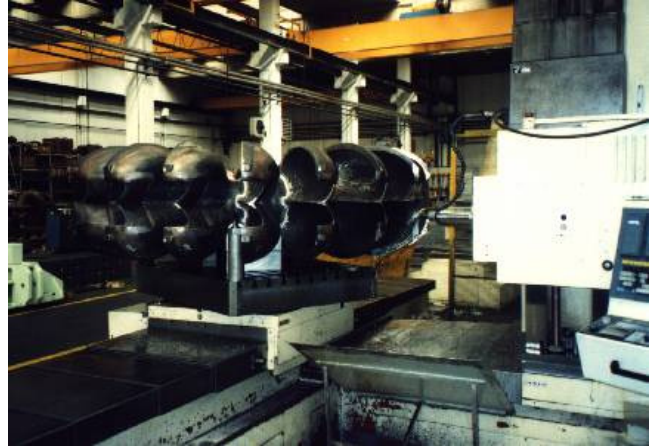
Fig. 4 – CNC milling of bucket's profile

- CNC milling of the profiles, by the references traced in the phase of the preliminary machining (s. Fig. 4). The milling program of the hydraulic profiles is written on the basis of templates and drawings, if available, or by an analysis of the most suitable hydraulic profile.

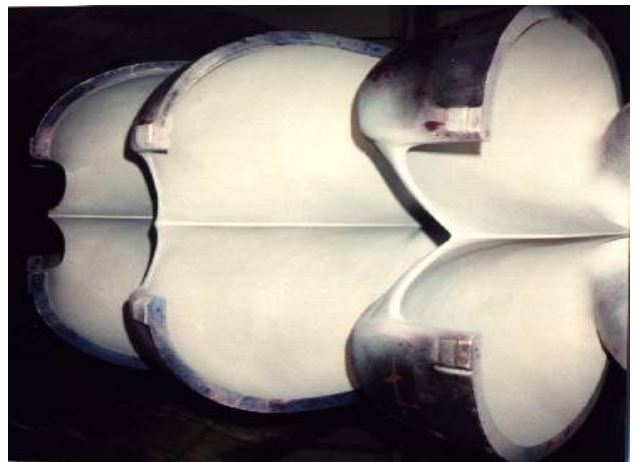
Fig. 5 – Non-destructive inspection (PT)

- Heat treatment.
- Polishing of the profiles.
- Final check: non-destructive tests (s. Fig. 5), balancing of the runner and a dimensional check.
