New Italian norms to regulate the non-destructive inspections in the manufacturing and in the maintenance of parts of hydraulic machinery

(*) Members of UNI Ad Hoc Working Group „Non-Destructive Inspections on Hydraulic Machinery“

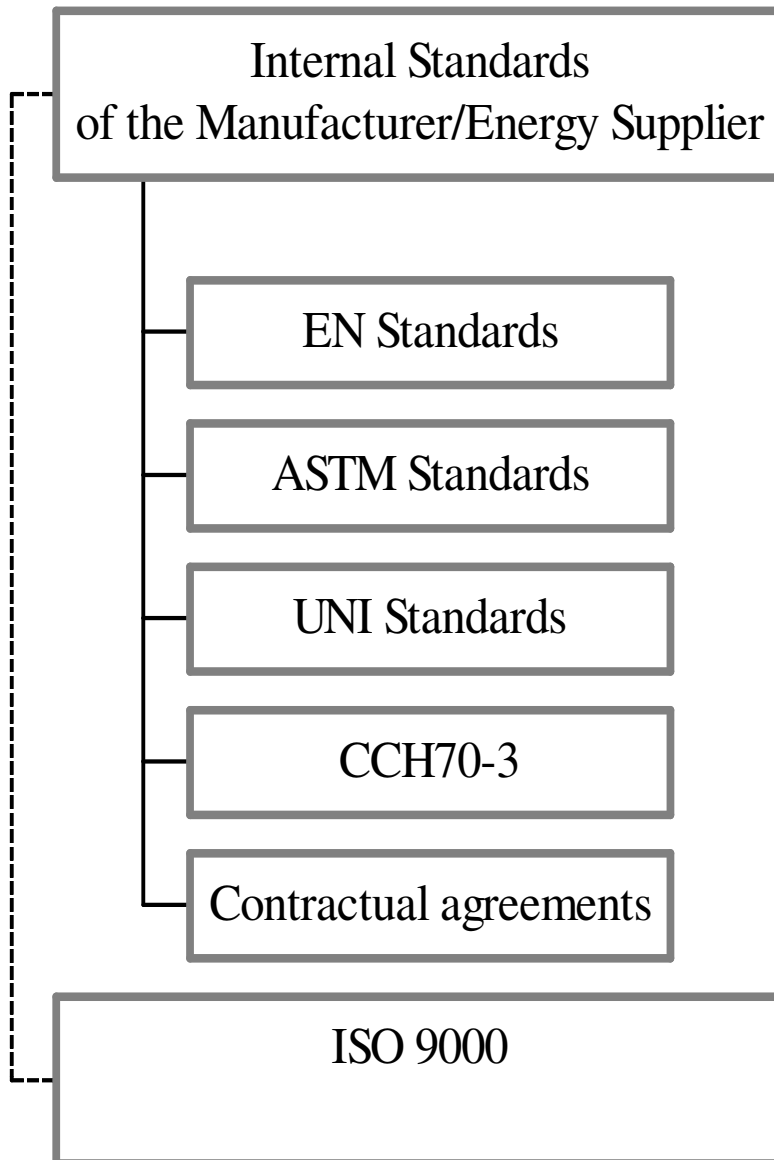
Fig. 1. Standards for destructive-testing in hydropower (overview)

At present there is no Italian or European Norm with the specific aim of being a reference point for hydropower. An overview of the standards commonly used for the testing of hydraulic machinery is shown in Figs. 1. and 2.

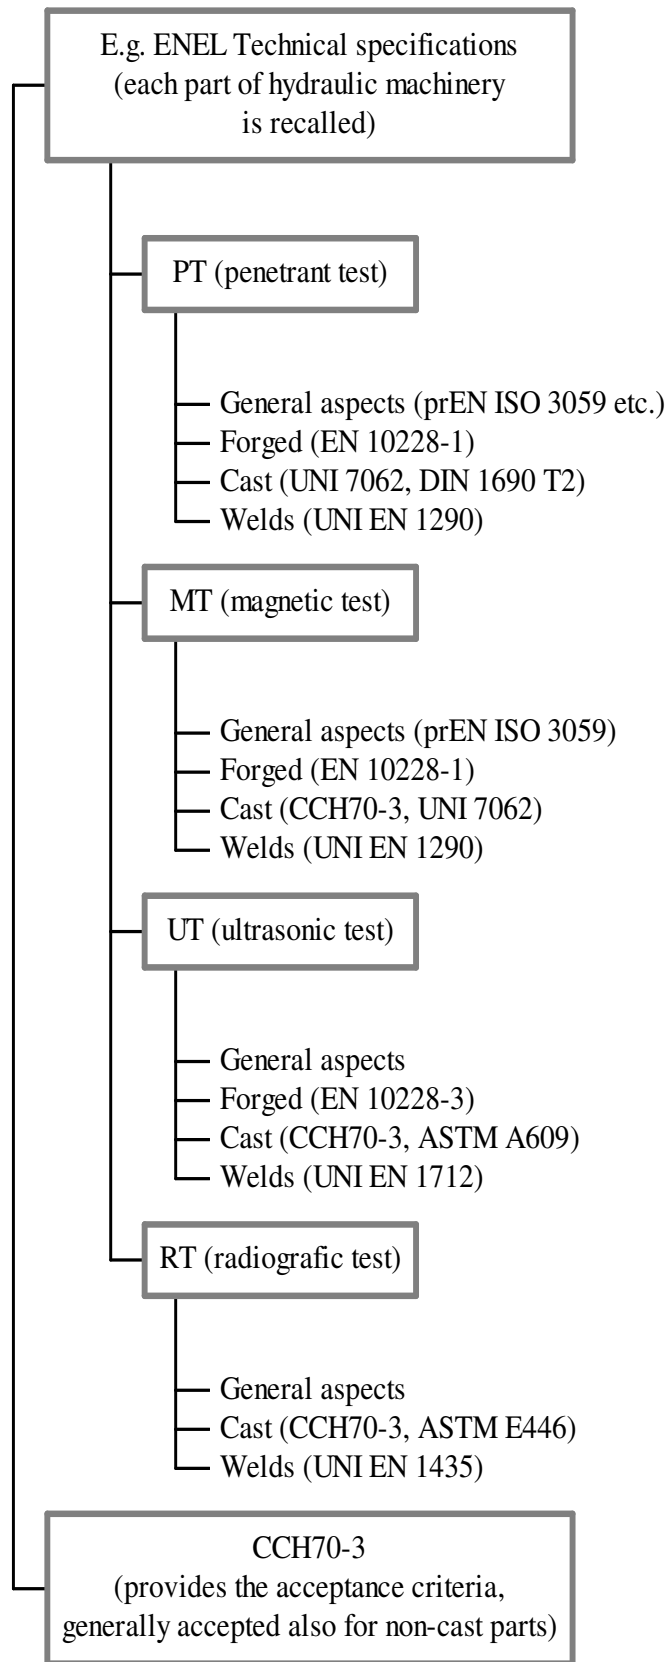
Fig. 2. Standards for destructive-testing in hydropower (detail)
