SPECTER S	INSPECTION REPORT					
	Project:	Date: 23-August-2012	Supplier:	Page: 1 of 6		
Client:						
Client's ref.:						
Inspecteam Project No						
Inspector's Name:						
Report date:	23	-August-2012				
Report No.:						
INSPECTION INFORMAT	ION:					
PO No.:						
Project Name:						
Materials Inspected:	PE	LTON RUNNER CASTING (in r	ough machined condition	n) – Unit 3		
Date of Previous Visit:						
Date(s) of Visit(s):	27	-June-2012				
Date of Next Schedule	ed Visit:

INSPECTION REPORT

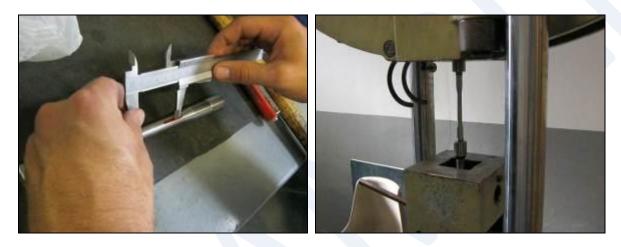
Mechanical test:

6.4	Mechanical Testing
	All equipments used during inspections were duly identified and found in a valid calibration status. Test specimens' type and quantity were found in compliance with ITP requirements.
	<u>Tensile test:</u> Test specimens were found ready machined in accordance with the requirements of standard and specification. Prior to carry out the tests, main specimen dimensions (diameter and gage length) were checked and found within allowable tolerances. Identification numbers for traceability and the hard stamp identification carried out during last visit were found indelibly marked on each specimen.
	All results of the test (yield strength, tensile strength, elongation %, reduction %) were in compliance with specification requirements and applicable material standard.
	Impact test: Test specimens were found ready machined in accordance with the requirements of standard and specification. Prior to carry out the tests, main specimen dimensions (specimen section and notch depth and centring) were checked and found within allowable tolerances. Identification numbers and the hard stamp identification carried out during last visit were found indelibly marked on each specimen.

Impact test was carried out at 0°C in compliance with the requirements of Material specification.
	All results of the test (single readings and average) were in compliance with specification requirements and applicable material standard.
	No objection was raised. Result: satisfactory.

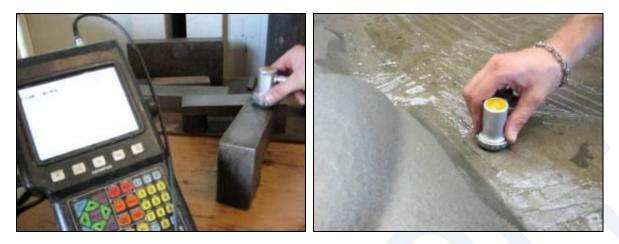
6.3	UT examination (random spot check 35%)
	The examination was carried out in accordance with applicable standards and specifications.
	An ultrasonic pulsed type instrument and suitable search beam units were used. Calibration was performed with the DAC technique on a suitable calibration block provided.

The surface was found free of extraneous material such as loose scale, paint, dirt, and so forth. A suitable couplant (contact past) was applied to carry out the test.
	The personnel was found duly qualified level II SNT-TC-1A / level 2 EN 473. Used equipments were duly identified and found in a valid calibration status at the time of inspection.
	No indication beyond acceptable limits was found. Offered test certificate was stamped, signed and dated by the writer for witness.
	No objection was raised. Result satisfactory.
